HIGUERA STREET

CENTRAL COAST
ENGINEERING

RE: Higuera Street Improvement Plans

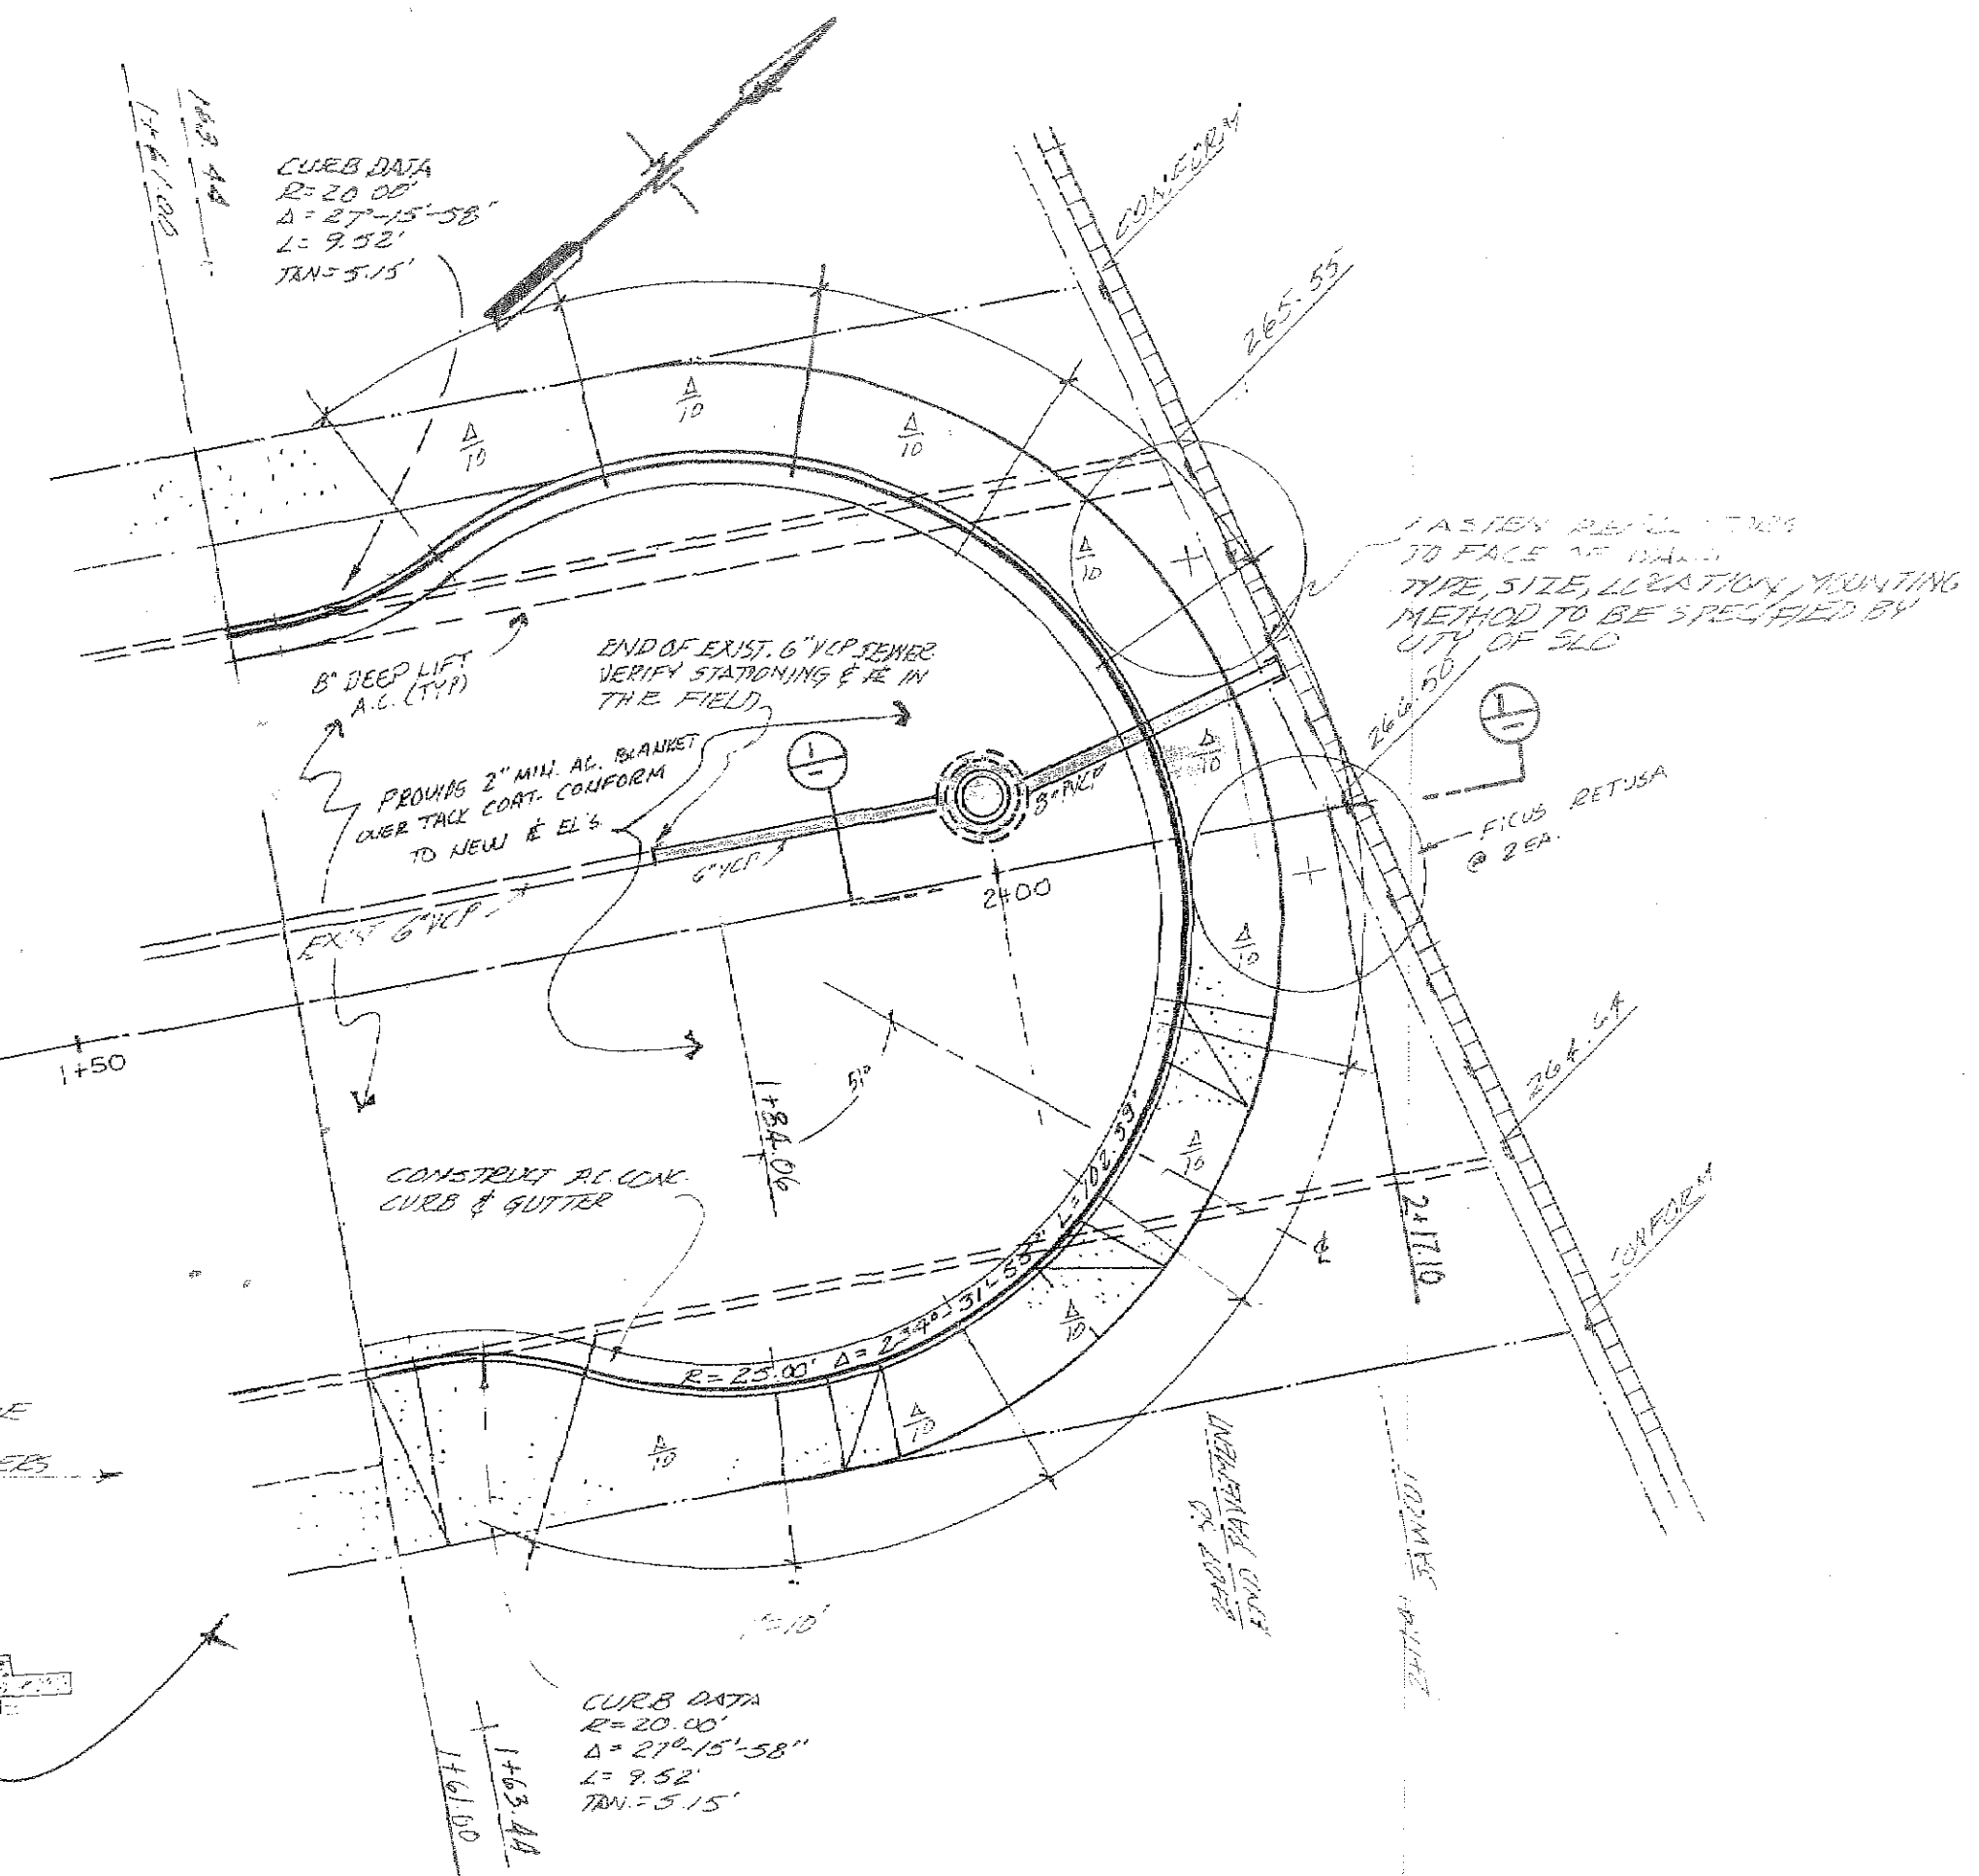
SECTION 1-5

STREET TREES
IN TREE WELLS PLANT
EITHER PYRUS CALLERYANA
OR FICUS NITIDA

Please find attached copies of the above improvement plans. The plans show changes to the cul-de-sac curb elevations. While the grades differ from those approved, they better fit the existing improvements and should provide a better finished product. The reasons for the change are as follows:

- 1) Once the end of the existing street was excavated, it was found that pavement existed at the cul-de-sac end and that it was approximately 0.5' below design grade. Lowering the high point by 0.44' provided a better fit to the existing pavement while allowing a 0.08' minimum overlay for the final paved surface.
- 2) The back of sidewalk grade for the approved drawing was 0.16' higher than the walkway tie in elevation at the lot on the northwesterly cul-de-sac. The proposed modification places both pavement sections at the same elevation.
- 3) Lowering the cul-de-sac at the Lee property allowed for property drainage to flow across the sidewalk and thereby eliminate a potential ponding problem in the lawn area.

Although the gutter grade at the northwest portion of the cul-de-sac is below 1% (0.91%), there are no anticipated drainage problems. There is little tributary area for this 50' stretch of paving.
